Rocky Flats Environmental Technology Site

# Building 776/777 2<sup>nd</sup> Floor Final Survey Report

**Survey Unit:  
776037**

October 2004

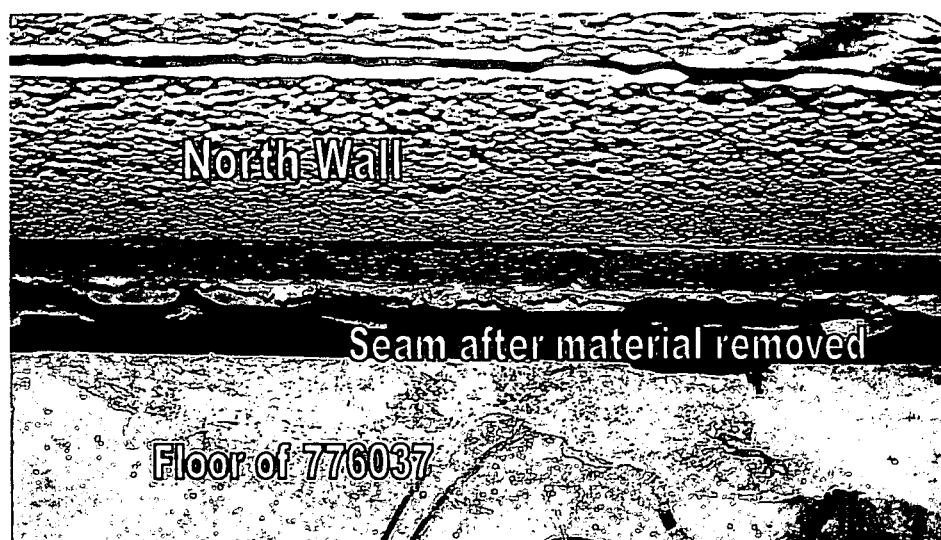
Two inaccessible areas were identified on the floor of survey unit 776037 located in survey grid 37-19 and 37-43. The contaminated seam along the north wall in grid 37-19 had elevated sodium iodide readings that were believed to originate from the joint material that filled the seam. Initial estimates indicated contamination levels up to 1,661,670 dpm/100cm<sup>2</sup>. As the material was removed sodium iodide readings increased. It was discovered that some of the elevated readings from the original survey were the result of "shine" from the top of the north wall of room 430 below. The highest reading on the material removed from the seam was 568,875 dpm/100cm<sup>2</sup>. The average value for the joint material that was removed from the seam was 388,223 dpm/100cm<sup>2</sup> (17.49μCi/m<sup>2</sup>). Approximately 15 feet (4.7 m) of this material was removed from a crevice that was 6 inches (0.15m) deep and contaminated on both sides. The amount of activity removed from the seam on the north wall is estimated as, 1.41 m<sup>2</sup> x 17.49μCi/m<sup>2</sup> = 24.7μCi.

Picture 1.0 Seam after remediation

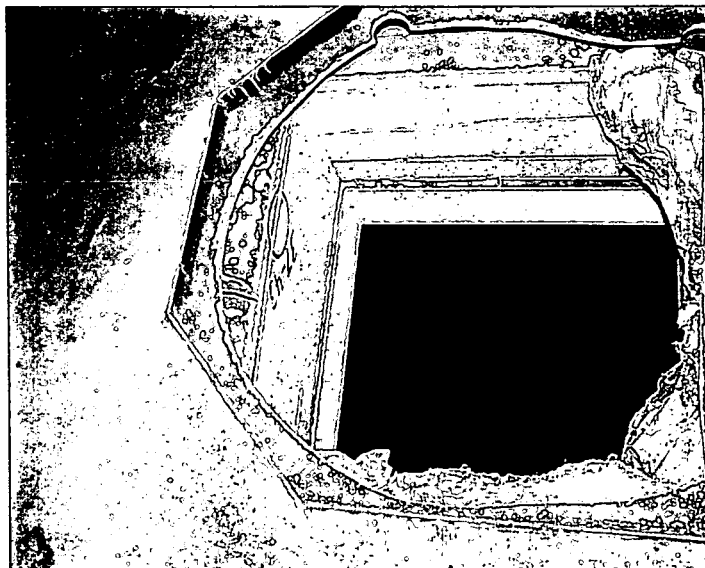
In grid 37-43, contaminated pieces of wood were found inside of the penetration that led down to the first floor. The boards were 2 inches (0.05m) thick, 12 inches (0.3m) wide and approximately 18 inches (0.46 m) long. The four boards were contaminated to an average level of 400,659 dpm/100cm<sup>2</sup> (18μCi/m<sup>2</sup>). The boards were removed and only "shine" from survey unit 776016 was detected in the area the boards had occupied.

**Picture 3.0 Floor penetration in grid 37-43 from above**

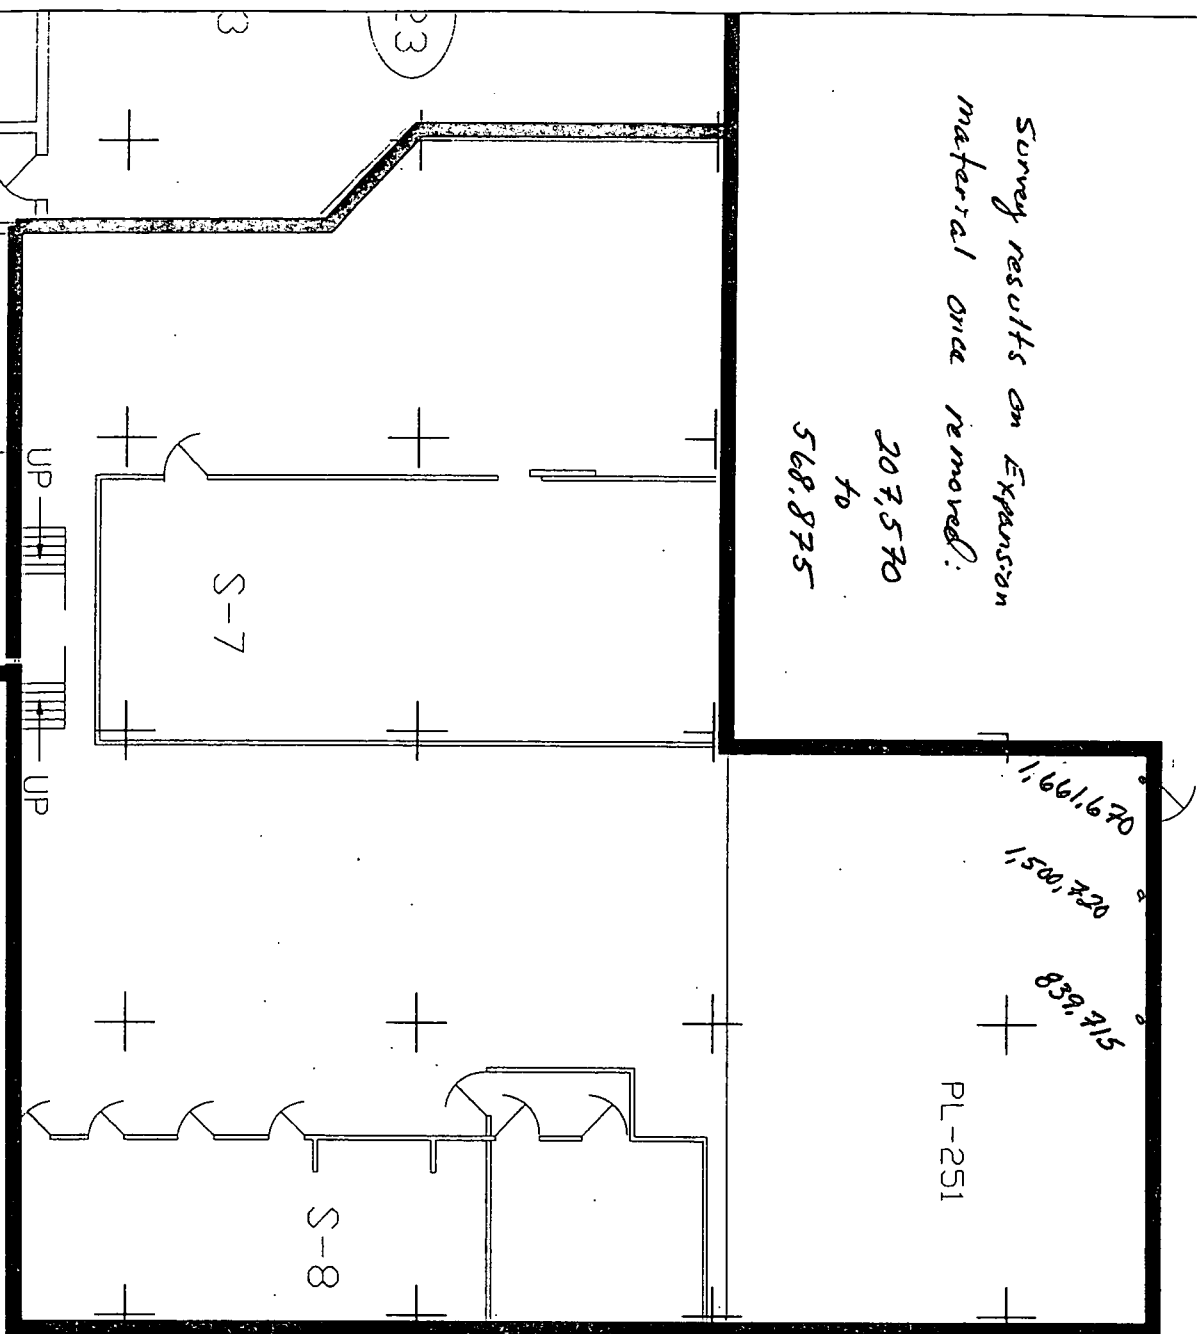
Expansion joint prior to remediation

Survey results on Expansion  
material once removed:

207,570  
to  
568,875
